Collision in Space

Human factors such as inadequate visual displays and operator fatigue played significant roles in the collision of Space Station *Mir* and *Progress 234*.

BY STEPHEN R. ELLIS

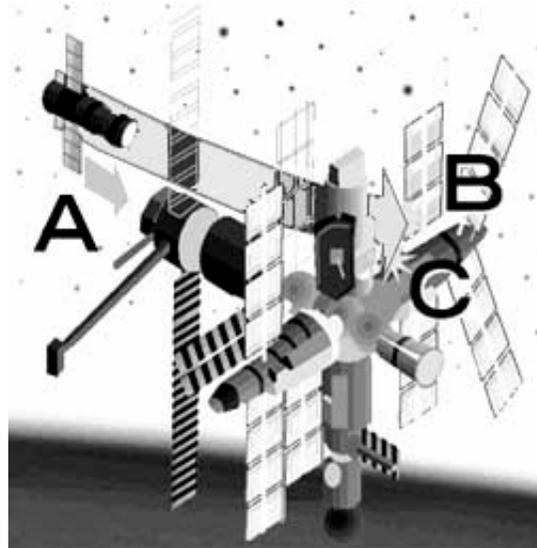
Impact was about 3 m/sec (~7 mph) on the solar arrays and hull of the Spektr module (Figure 2). Estimates of the rate of air loss from the puncture showed that the crew had about 28 minutes before they needed to abandon the station because cabin pressure would reach the

Figure 2. Arrows show the approximate collision path of Progress 234. It approached Mir from above, passing along the Base module from A and striking the Spektr Module's solar panels at B and Spektr itself at C.

There were three immediate causes of the crash: 1) The higher than planned initial closing rate, 2) Late realization that the closing rate was too high and 3) Incorrect final avoidance maneuvering. This last cause is based on post crash simulations that have explored the possible outcomes of alternative avoidance maneuvering which show that a collision could have been avoided in many cases, include the case of no maneuvering at all (NASA, 1997-1999). Because the final pattern of maneuvering thrusts do not indicate that the commander attempted to break off the docking attempt (NASA, 1997-1999; Erkenwick, 1999), the actual contact might be described as controlled flight into collision somewhat analogous to "close in" landing short accidents in aviation (Wiener, 1977).

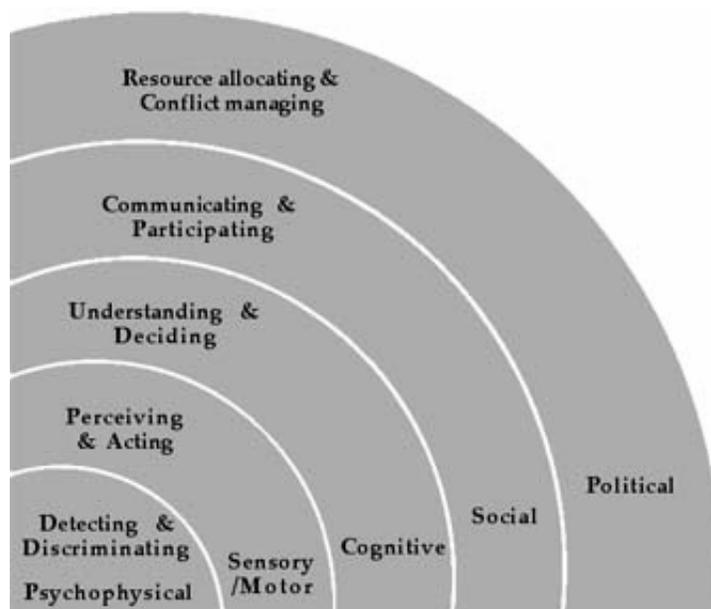
Post collision analysis has also identified human factors contributions to the incident in that the crew had been under stress due to repeated systems failures and lack of sleep. But human factors may be seen as potentially an even more pervasive contributor to the incident. As shown in Figure 4, the elements of human factors range from underlying low level psychophysical phenomena to very high level political issues. Factors potentially contributing to the crash can be found at virtually every level illustrated in this figure.

Figure 3. The human factor elements of the collision.
