The Challenge of Emergency and Abnormal Situations for Flight Attendants

By Nora C. Marshall Chief, Survival Factors Division NTSB

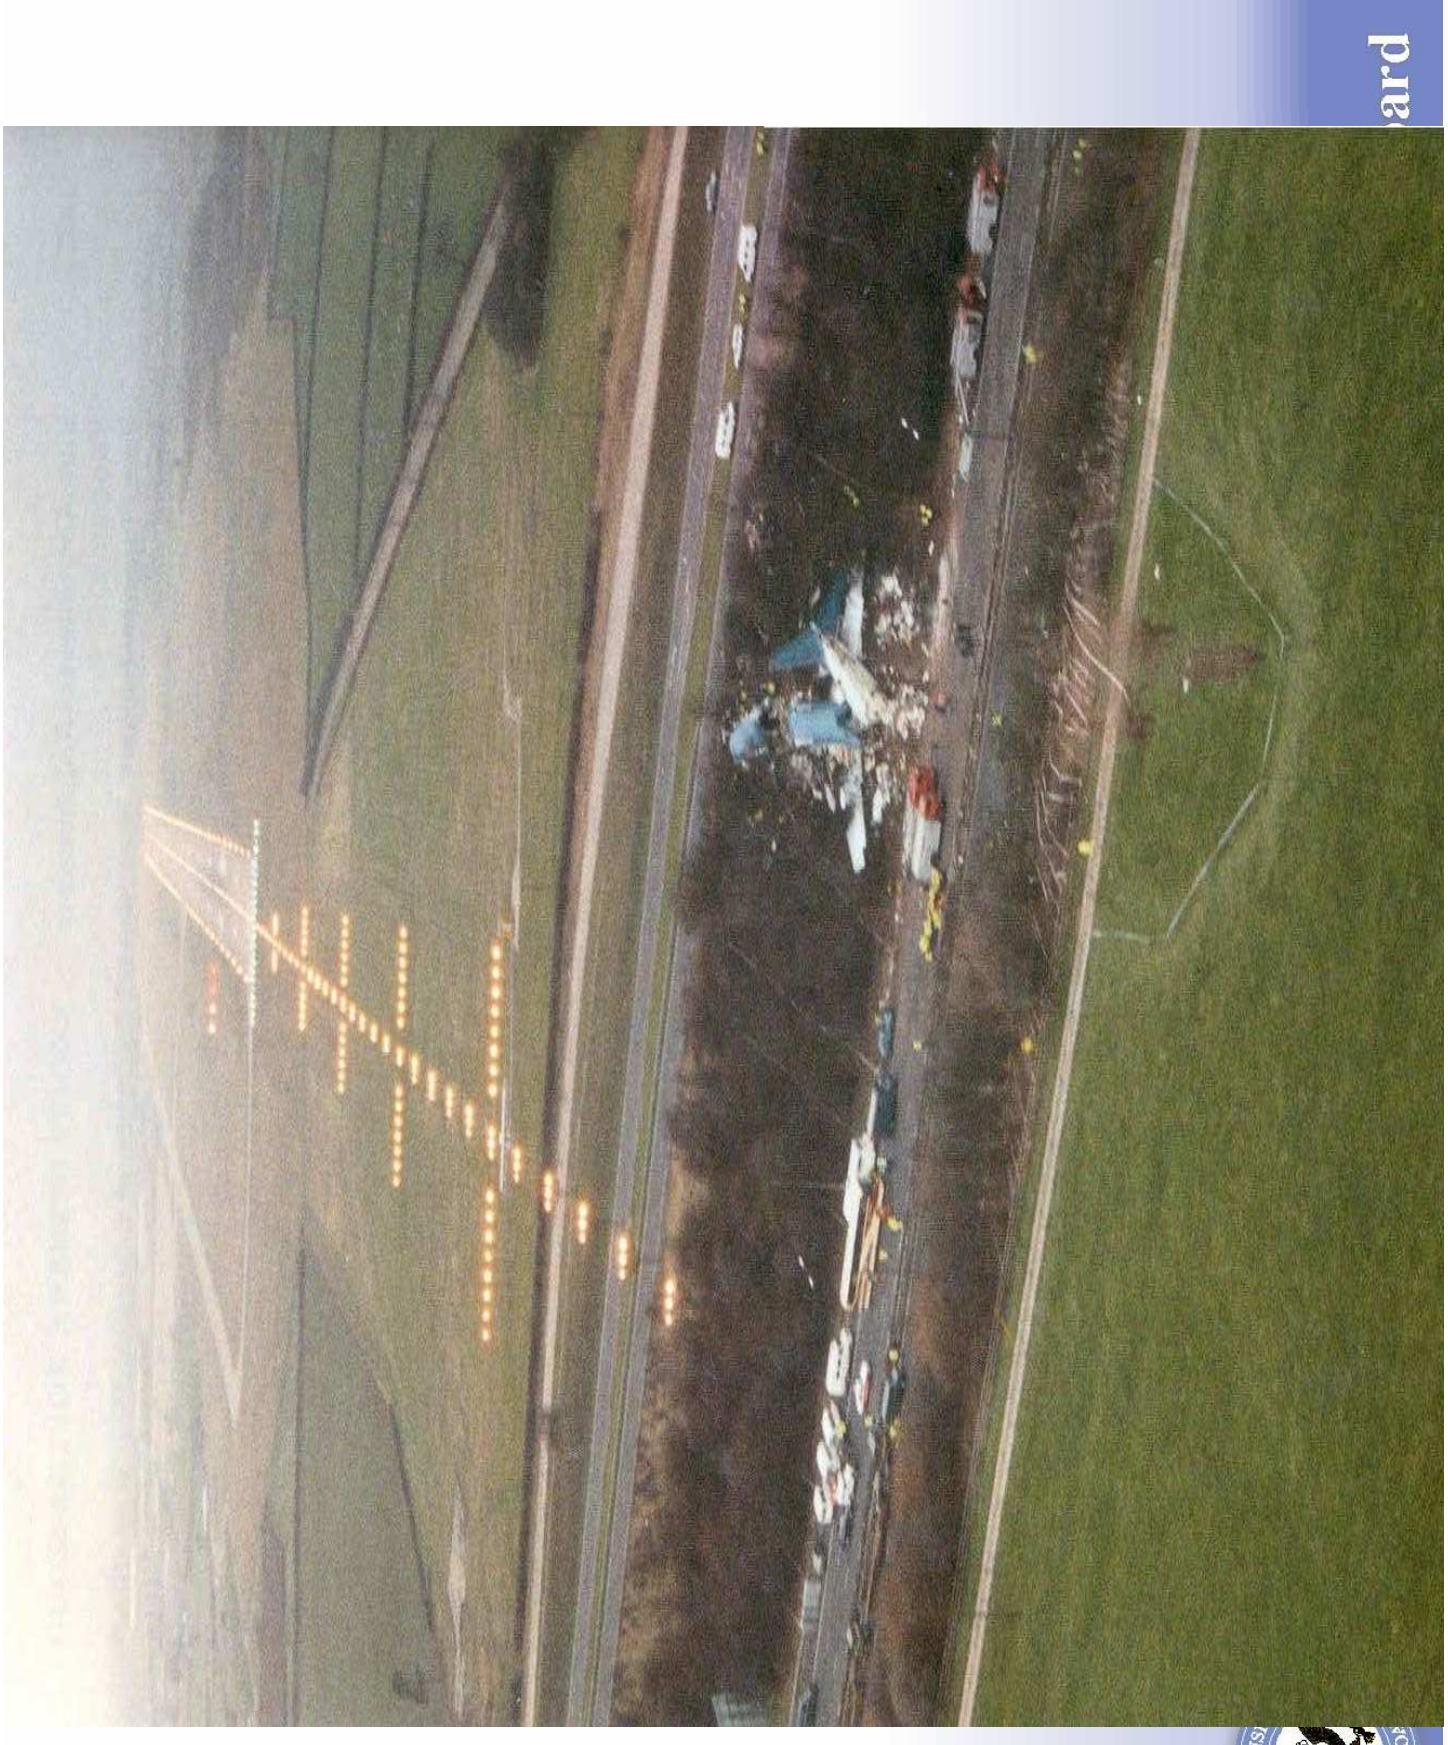
M-1 Accident, Kegworth, UK (Continued)

- The captain made a PA announcement that he had shut down the right engine
- During descent to East Midlands there was an abrupt reduction in power to the No 1 engine and a fire warning occurred.
 Attempts to restart the No 2 engine were unsuccessful.

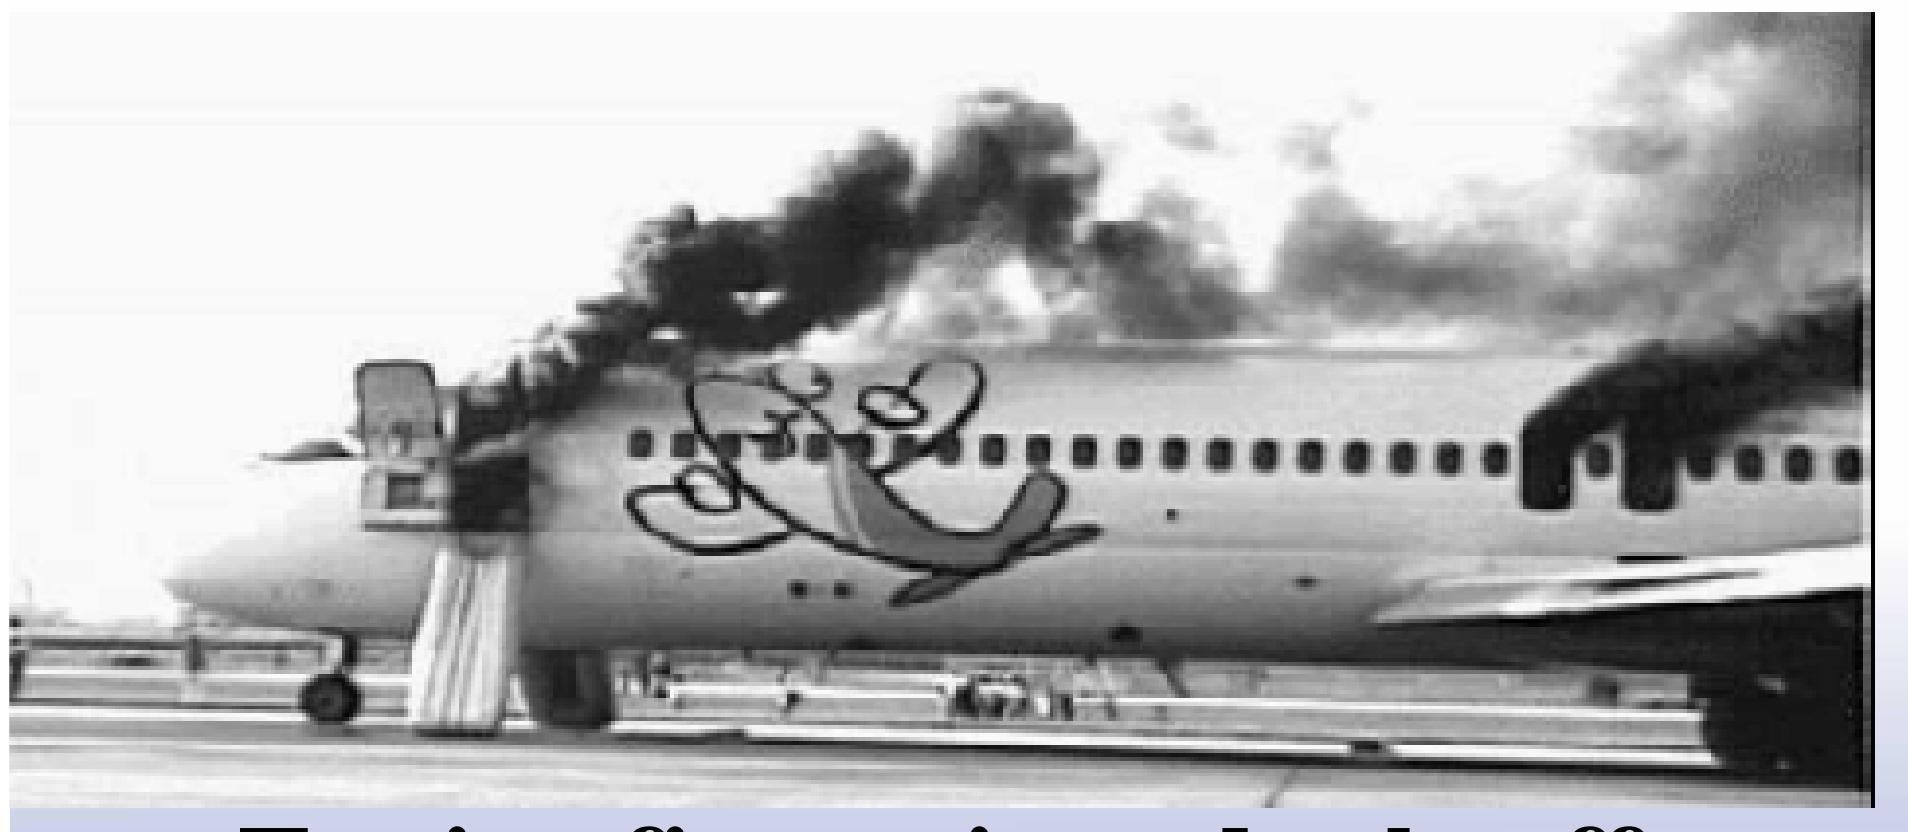
DC-9 Atlanta, GA June 8, 1995

• Engine fire, rejected takeoff, Cabin fire, evacuation portation Safety Board
