DataComm in Flight Deck Surface Trajectory-Based Operations

*Deborah L. Bakowski¹, David C. Foyle², Becky L. Hooey¹, Glenn R. Meyer³,
Cynthia A. Wolter¹*

¹San Jose State University at NASA Ames Research Center
²NASA Ames Research Center
³Dell Services, Federal Government
Moffett Field, CA
debi.bakowski@nasa.gov

CHAPTER 25

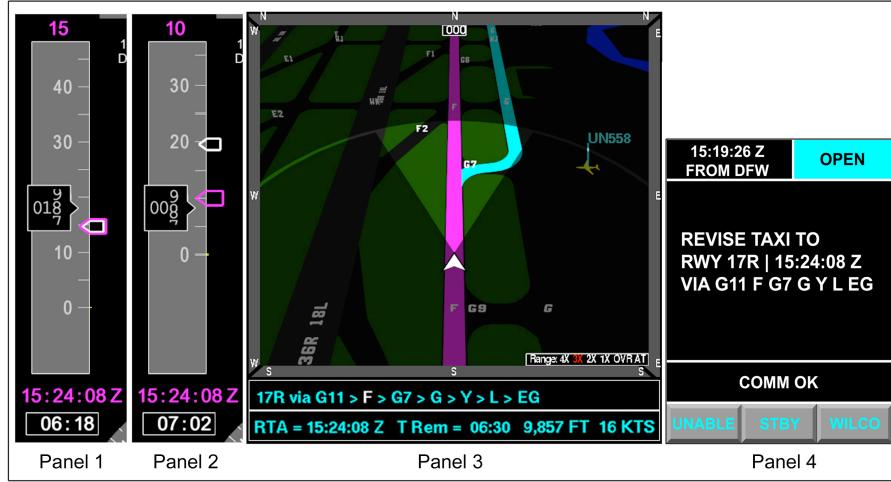
Figure 1 PFD: on straightaway (panel 1), and in turn (panel 2). TND: pending taxi route change with preview information in cyan (panel 3). DataComm: pending taxi route change (panel 4).

The PFD was modified for taxi operations by expanding (doubling) the speed scale from 0-60 kts. Advised straightaway speed, as calculated by the RTA algorithm, was displayed as a magenta analog pointer ("speed bug") on the speed tape and digitally in magenta directly above the speed tape (see Figure 1, panel 1). As shown in Figure 1 (panel 2), upon entering a turn, the magenta advised speed bug dropped to 10 kts (per taxi SOPs), while the white inner speed bug continued to dynamically indicate the straightaway speed required to meet the RTA. The PFD also included the current speed, shown as a sliding indicator with digital value inside (18 kts in Figure 1, panel 1), RTA time (Zulu) in magenta, and time remaining to the RTA (min:sec) in the white box.

A Taxi Navigation Display (TND) depicted the airport layout to aid the pilots in airport navigation. The ownship aircraft's position, shown as a white chevron, and other aircraft traffic within the ownship's 1,250 ft declutter circle, shown as yellow aircraft icons, were updated in real time (see Figure 1, panel 3). When the initial taxi clearance, sent via the DataComm, was accompanied by preview information, the TND populated with details of route: a graphical route on an overview map,

clearance text, RTA, time remaining to RTA (T Rem), route distance, and advised straightaway speed in cyan (see Figure 1, panel 3). Once accepted by the flight deck, clearance information was loaded into the PFD and the TND updated with the taxi clearance displayed as a magenta route, in perspective, track-up, and with text of the accepted clearance. When a mid-route taxi route change or RTA change was accompanied by preview information, the RTA, time remaining, distance remaining, and advised speed of the pending route were displayed in cyan. Turn graphics and route text were also displayed for taxi route changes. RTA location in the departure runway queue area was displayed as a white, dashed line across the ownship route on the TND, visible on the TND as the pilot neared it.

The DataComm touchscreen interface was located aft of the throttles between the two pilots. At the start of the trial, the flight deck received a DataComm with an expected taxi and departure clearance, followed by an initial taxi clearance. Taxi route changes (Figure 1, panel 4), RTA changes, and departure clearance changes were delivered via the DataComm during taxi. The DataComm followed a format similar to the European Airport Movement Management by Advanced Surface Movement Guidance and Control System, Part 2 project (EMMA2; Airbus, Thales, DSNA, 2009). When a clearance was delivered via DataComm, three touchscreen response buttons were available to the pilot to respond to ATC: Unable, Standby, and Wilco. The DataComm display included the message sent time in the upper left corner, an indicator of message status in the upper right hand corner (i.e., “OPEN” while ATC was awaiting a response from the flight deck, or “WILCO”, “STBY”, or “UNABLE” after a response was selected and sent to ATC), and status of the connection (i.e., “COMM OK” or “RECEIVED BY ATC” when ATC received the crew’s response). After the crew responded “WILCO” to a clearance, the DataComm text turned magenta, as an indication of acceptance.

If the crew accepted the clearance, the First Officer responded by selecting "WILCO" on the DataComm, and the Captain released the emergency brake and began taxi. When the clearance was accepted, the RTA, time remaining, and advised speed were loaded into the aircraft avionics and displayed on the PFD (see Figure 1, panel 1), while the magenta route was displayed on the TND (panel 3).

During each of the nine experimental trials, the crew received a taxi route change, an RTA change, a departure clearance change, or a verbal instruction from ATC to stop for crossing traffic. When a taxi route change was accompanied by preview information (see Figure 1, panel 3), pilots were able to use the cyan graphical route depicted on the TND to note their position and locate the required turn. When an RTA change was accompanied by Preview, pilots were able to use the advised speed to determine whether it was reasonable/acceptable to meet the revised RTA.
